Environmental Risk Assessment related to potential gas migration from water injection well ROW-7 at Rossum-Weerselo

Restricted SR.16.11849 August 2016

by (GSNL-PTS-TSGW) (GSNL-PTS-TSGW) (GSNL-PTS/TESC)

#### Shell Global Solutions International B.V., Rijswijk

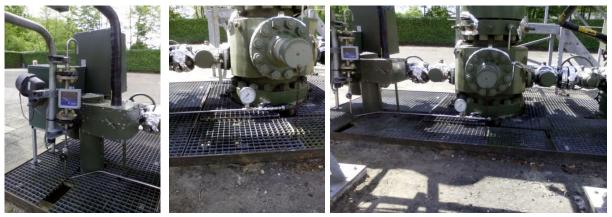
Because of the encountered gas bubbling still occurring in the cellar in March 2015 a venting assembly was subsequently (re-)installed by NAM (refer to Figure 2) with a gas cap placed on the wellhead, connected to a vent assembly and to a variable area flow meter (Brooks MT3809). Pressure build-up (50 to 100mbar) and bubbling is currently observed in the cellar while the valve of the vent assembly is kept closed. When opening the valve, gas is rapidly released and the meter does not detect any flow after approximately 10 seconds so that the current metering assembly does not allow for an estimation of the continuous leak rate.

Figure 2: Venting Assembly installed at ROW-7.

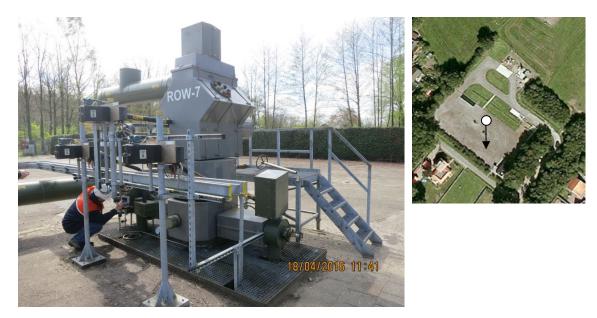
Figure A2.1: Well head of ROW7; taken north of well looking to southern corner of site (indicated by point and arrow on aerial photo).

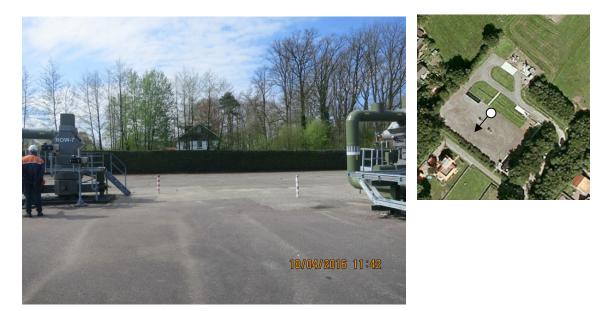
Figure A2.2: Well head of ROW7 (left) and well ROW2 (right) at ROW2 site. Taken north of well looking to southeastern corner of site (indicated by point and arrow on aerial photo).

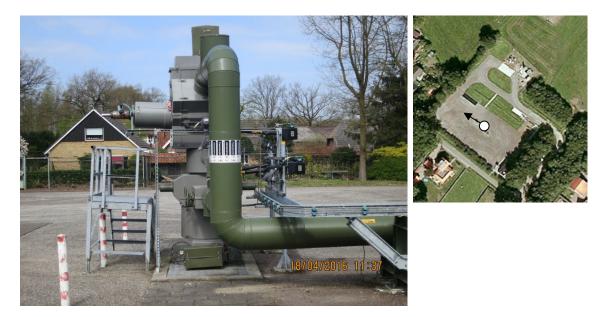
Figure A2.3: Well head of well ROW2 (right) at ROW2 site. Taken north of well looking to west site boundary (indicated by point and arrow on aerial photo).
